# Manhole Inspection Summary

Manhole # S11GG2002MH

**Location** Address: **2206 ROGENE DR**

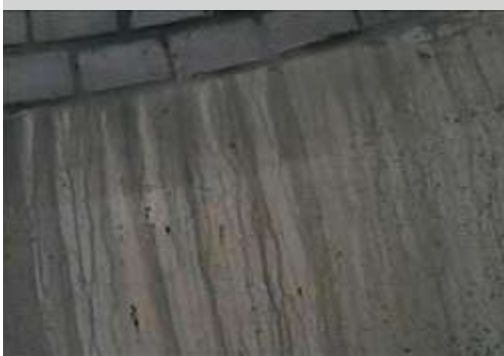
Defect

Infiltration: ☐ None ☒ **Joint** ☐ Cracks ☐ Mortar ☐ Roots ☐ Wall

Corbel infiltration.

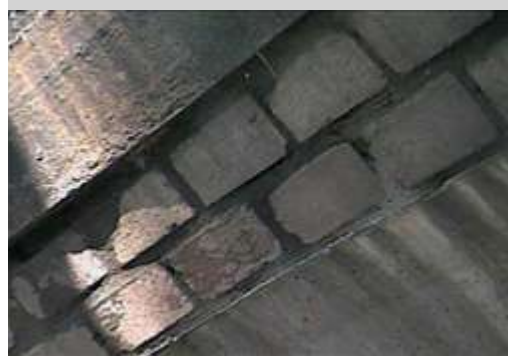
Defect

☒ **Leaks**

Infiltration: ☐ None ☒ **Joint** ☐ Cracks ☒ **Mortar** ☐ Roots ☐ Wall

Frame leaks. Adjustment infiltration.

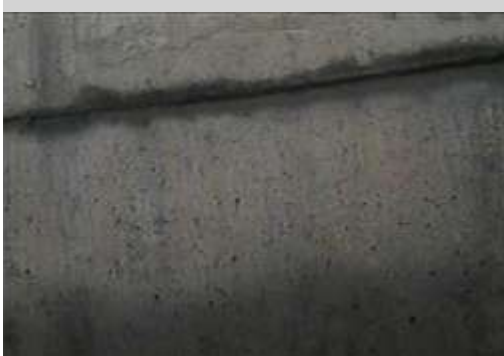
Defect

Infiltration: ☐ None ☒ **Joint** ☐ Cracks ☐ Mortar ☐ Roots ☐ Wall

Barrel infiltration.

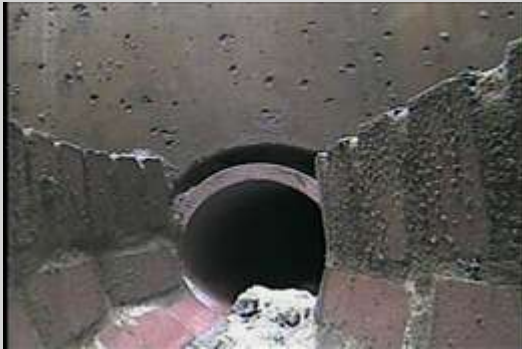
### 8 in. Circular Gravity Sewer Pipe Out @ 12 O'Clock

Comments **The O12 pipe seal is not flush to the pipe.**

Deposits: ☐ None ☐ Mud ☐ Sludge ☒ Debris ☐ Grease

Silt Depth: **0** (in.) Deposits Extent: **Light**

Infiltration: **Evidence** Pipe Seal Cond: **Unknown**

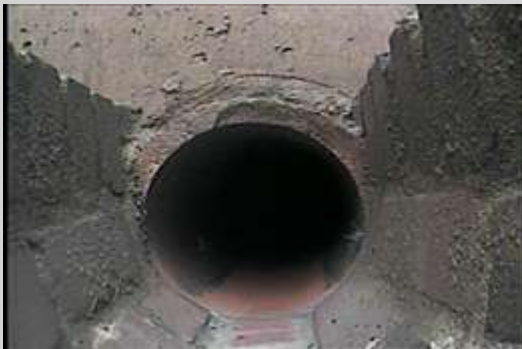
### 8 in. Circular Gravity Sewer Pipe In @ 6 O'Clock

Infiltration: **Evidence** Pipe Seal Cond: **Unknown**
